Manhole Inspection Summary

Manhole # S21WW1039MH

Insp Date: **11/29/06 12:57 PM**

Location Address: **CROSS KEYS RD**

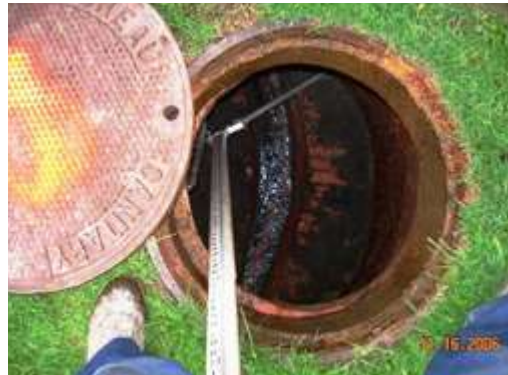
Top View

Bench ☒ Exists Material: **Brick** ☐ Parged ☒ **Debris** (not Condition related)

Bench debris.

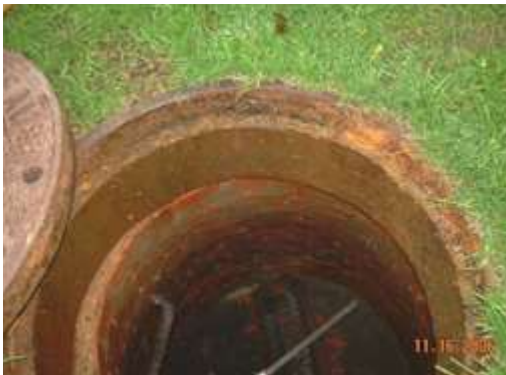
Defect

Frame Offset: **1** (in.) Condition: ☐ Sound ☐ Cracked ☒ **Leaks**

Infiltration: ☐ None ☒ **Joint** ☐ Cracks ☐ Mortar ☐ Roots ☐ Wall

Frame leaks. Frame offset. Adjustment infiltration.

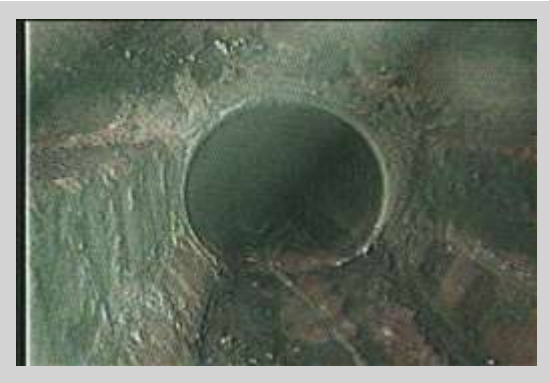
8 in. Circular Gravity Sewer Pipe Out @ 12 O'Clock

Deposits: ☐ None ☒ **Mud** ☐ Sludge ☒ **Debris** ☐ Grease

Silt Depth: **0.5** (in.) Deposits Extent: **Light**

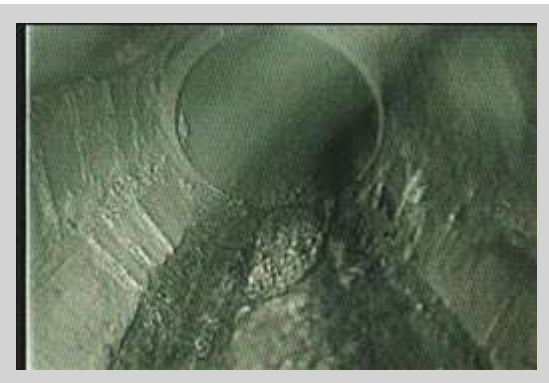
8 in. Circular Gravity Sewer Pipe In @ 7 O'Clock

Deposits: ☒ **None** ☐ Mud ☐ Sludge ☐ Debris ☐ Grease
